# Top GE engineer lifts lid on wind turbine collapse probe findings

Major investigation suggests variety of factors rather than 'single systemic issue' behind first four of five incidents

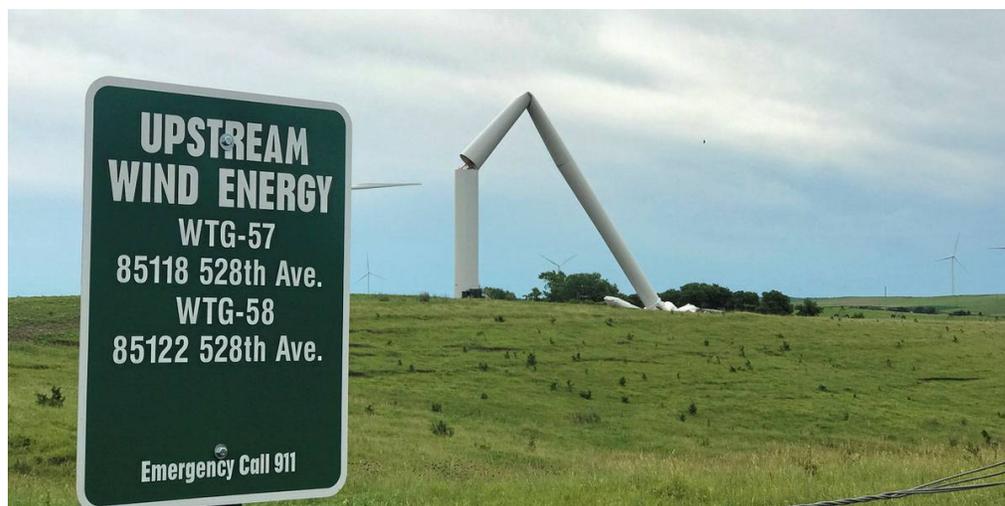
The third in the sequence of turbine collapses in Nebraska. Photo: LuAnn Schindler

"A blade that was damaged prior to installation was evaluated and repaired using our standard procedures. What was unknown was that there was additional damage hidden inside the blade that was not detected and that damage ultimately resulted in a crack and the blade detached near the point of repair. Under high wind operating conditions, that led to an imbalance and overwhelmed the tower."
